LABORATORY EVALUATION OF A SHIPBOARD MULTIFUNCTIONAL WASTE INCI--ETC(U)
OCT 79 F CROWSON, J A BYRNE, W W JONES

NSWC/TR-79-264

4. TITLE (and Subtitle) LABORATORY EVALUATION OF A SHIPBOARD MULTIFUNCTIONAL WASTE INCINERATOR (MFI). PHASE II.	5. TYPE OF REPORT & PERIOD COVERED Final rept.	6. PERFORMING ORG. REPORT NUMBER

7. AUTHOR(s) F. J. Crowson J. A. Byrne W. W. Jones	8. CONTRACT OR GRANT NUMBER(s)	
9. PERFORMING ORGANIZATION NAME AND ADDRESS Naval Surface Weapons Center (G51) Dahlgren Virginia 22448	10. PROGRAM ELEMENT, PROJECT, TASK AREA & WORK UNIT NUMBERS NIF

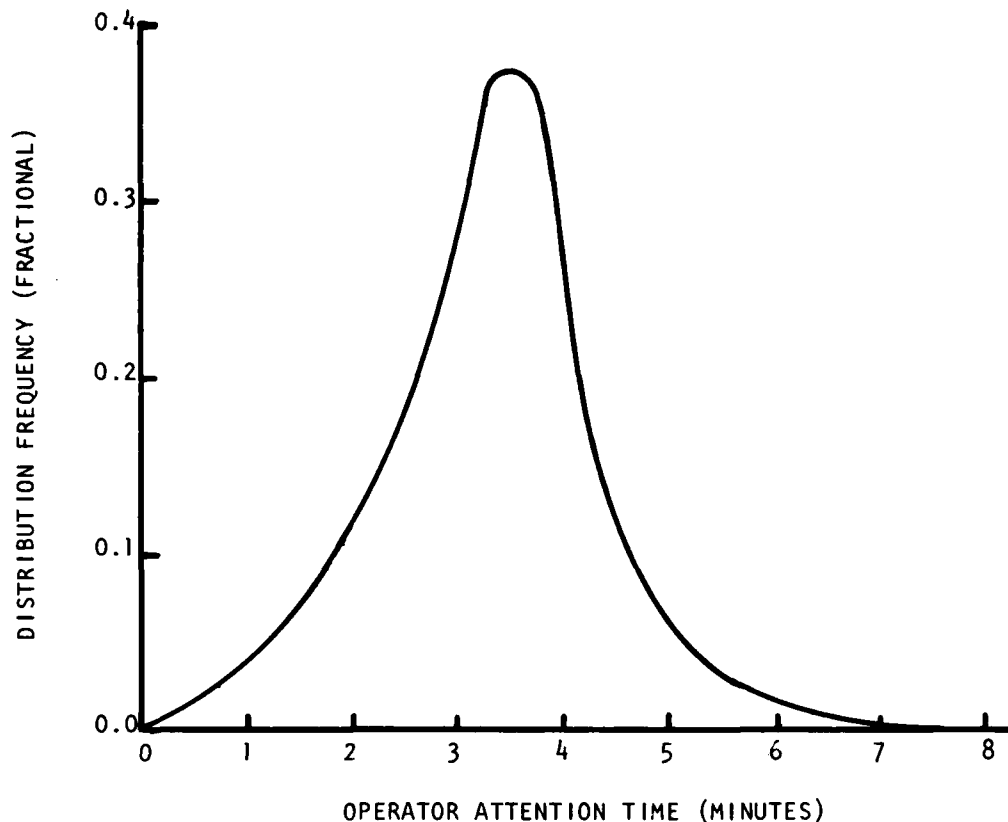
Figure 4. Distribution of Operator Attention Time

The operator attention time for the MFI-II is required not to exceed 5 min/hr. The average value for the entire 1200-hr test period was 3.4 min/hr, and the distribution for the operator attention time is shown in Figure 4. The requirement was exceeded 6 percent of the total test hours, primarily in the 4th and 5th hr of operation, during the first 37 tests and the last 10 tests. The excessive attention time was initially due to buildup of ashes and solid wastes (refuse or trash) in the firebox because of an improper setting on the ash door timer. The problem was alleviated by resetting the ash door timer, as per NAVSEC request, to allow the ash door to open on each full forward stroke of the ram. This action allowed ashes to be pushed from the firebox during each feed cycle, thereby reducing buildup. Operator attention time during the last 10 tests was increased because of increase in stoking as required to conduct the tests discussed earlier pertaining to the WLOH. Operator attention time was exceeded by only 1 percent during tests 38 through 140. Attention time during these tests was due to a series of isolated problems, such as initial debris behind the ram, one fire in the hopper that was cleared with a rake, and binding of the ram due to feed hopper warpage. Additionally, operator attention time during feeding is affected by low-density loose trash, which requires more feeds to process the required hourly weight of materials; however, this does not increase attention time beyond the 5-min/hr specification.

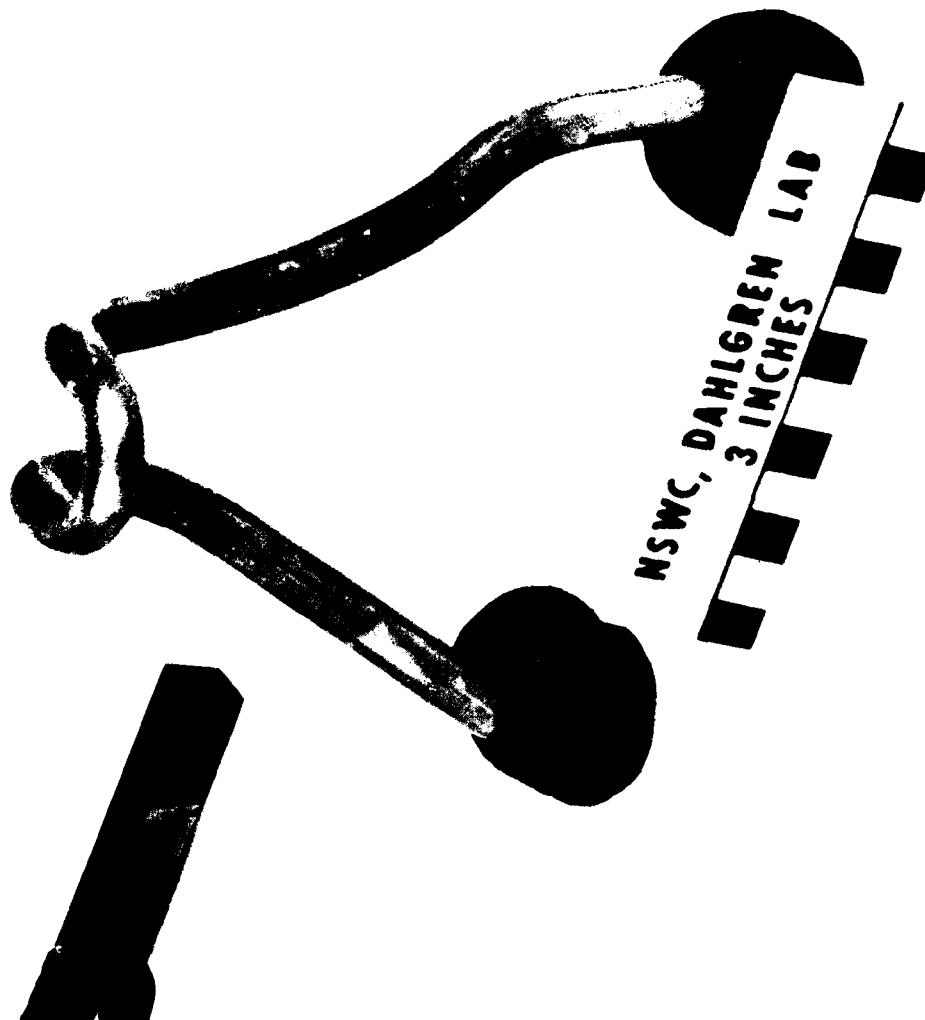
Figure 19. S-Shaped Refractory Anchors of MFI-II Unit

A redesign of the incinerator framework became necessary because of the vulnerability of the refractory to external vibrations and shock. The steel side panels were increased in thickness, and the refractory anchors were changed to sturdier S-shaped anchors (Figure 19) rather than the V-shaped anchors originally used to prevent movement of the refractory in any plane. Additionally, the anchors were bolted on all panels to facilitate future replacement of the refractory when necessary.
